Riparian Revegetation

Lessons from the Lockyer

Creek vegetation needed to slow erosion

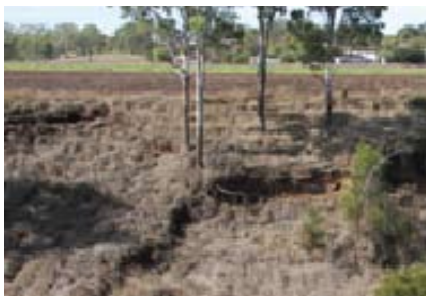
Trees holding their section of banks while bare areas slump – Lockyer Creek, near Gatton.

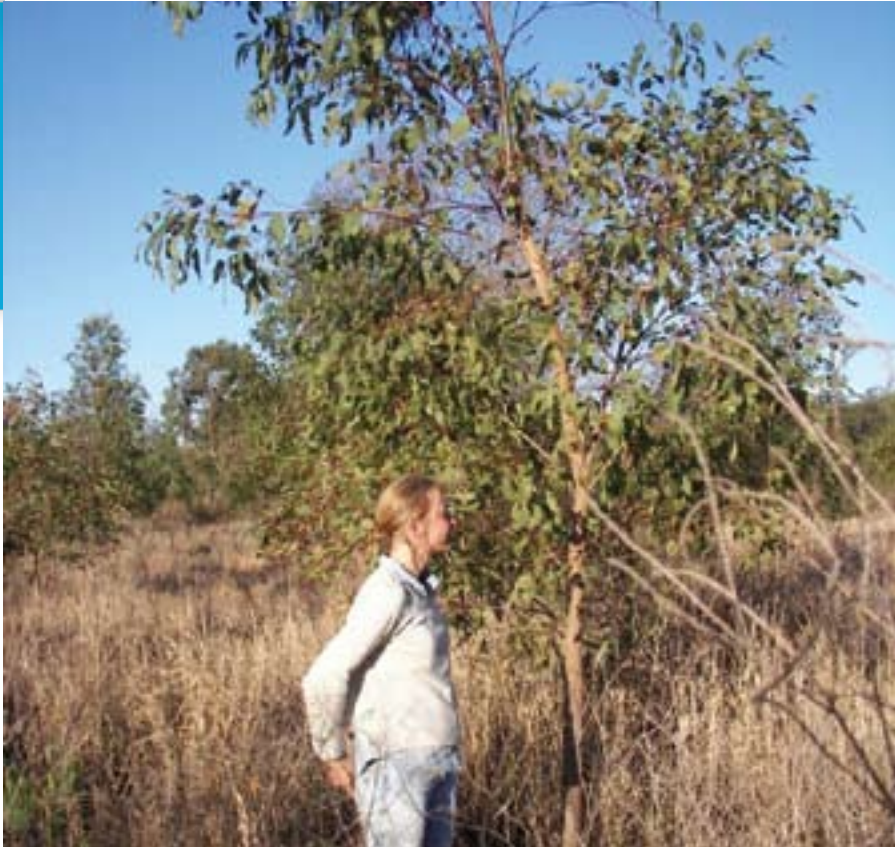
Case study 1

SEQ Catchments Lockyer Community Contact Officer, Fiona Bengtsson checks growth of three year old trees at Sandy Creek, Gatton By-pass.

The Department of Main Roads was involved in creating a wildlife corridor along the banks of Sandy Creek in 2004. The corridor is 250 metres long and is comprised of four rows on the alluvial terrace of Sandy Creek near the Gatton Bypass.

The fine sandy soils present at the site were completely dry prior to planting. To combat this, the ground was ripped and approximately 250 water well holes were dug. Into these wells, 20 to 30 litres of water was applied rapidly.

A few days after the initial watering, the trees were planted out. Endemic species were chosen for the site. These included Forest Red Gum (*Eucalyptus tereticornis*), Ironbark (*Eucalyptus crebra*) and Swamp Mahogany (*Lophostemon suaveolens*).

Two types of seedlings were used for the site; hiko trays with a root ball of 40 millimetres in diameter and net pots about half the size of hiko trays. Prior to planting, the tree seedlings were dunked in tubs to saturate the root ball.

Once the tree seedlings were placed into the moist soil, the soil was firmed well around them to ensure good root-soil contact. Then a cover of 50 millimetres of soil was introduced over the root ball and around the stem to hold moisture content while the roots penetrated more deeply. This initial root growth takes about one to two weeks.

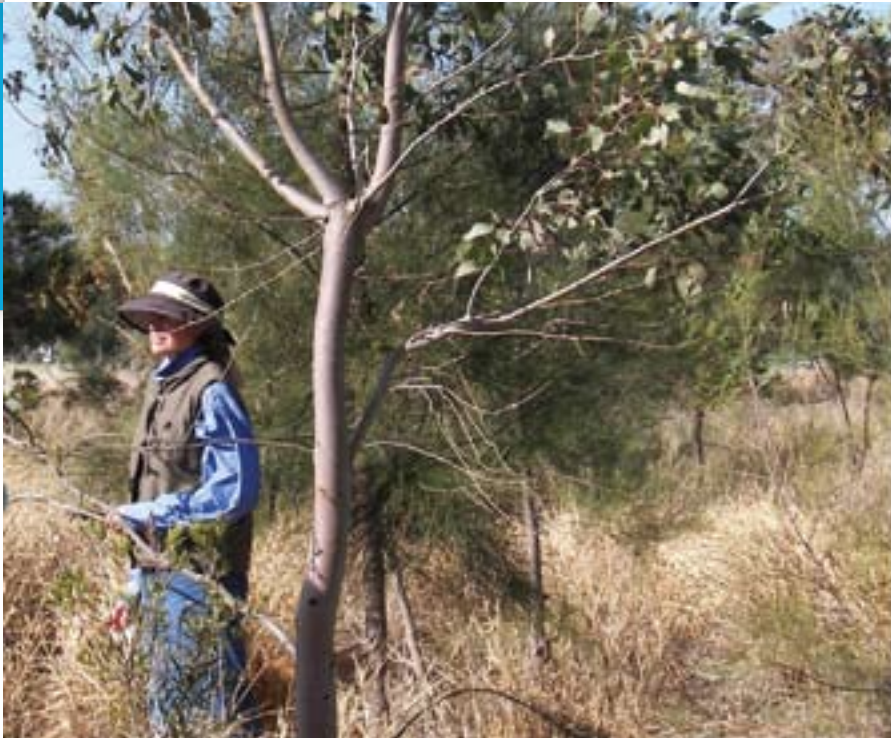
Case study 2

Forest Hill farmer Donella Van Der Est with a 3 year old forest red gum beside Laidley Creek.

In a riparian planting on Laidley Creek, Forest Hill, the trees are four to six metres high after only three years and the survival rate has also been high. But from their first riparian planting cattle producers Gordon and Donella Van Der Est are constantly evaluating and improving the processes used.

Weeds were controlled both mechanically and chemically with Fusilade® for grass control. Because Fusilade® is grass selective it can be sprayed over the top of trees. The loss of all grasses, however, resulted in a proliferation of weeds, which had to be chipped out and burnt.

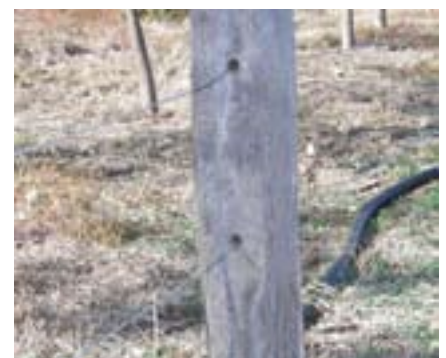
No catch – having 2 plain wires at the bottom of the fence reduces debris buildup.

A good feature of the Van Der Est's fencing is that the two bottom wires are plain wire which reduces the problem of debris catching on the wires so readily.

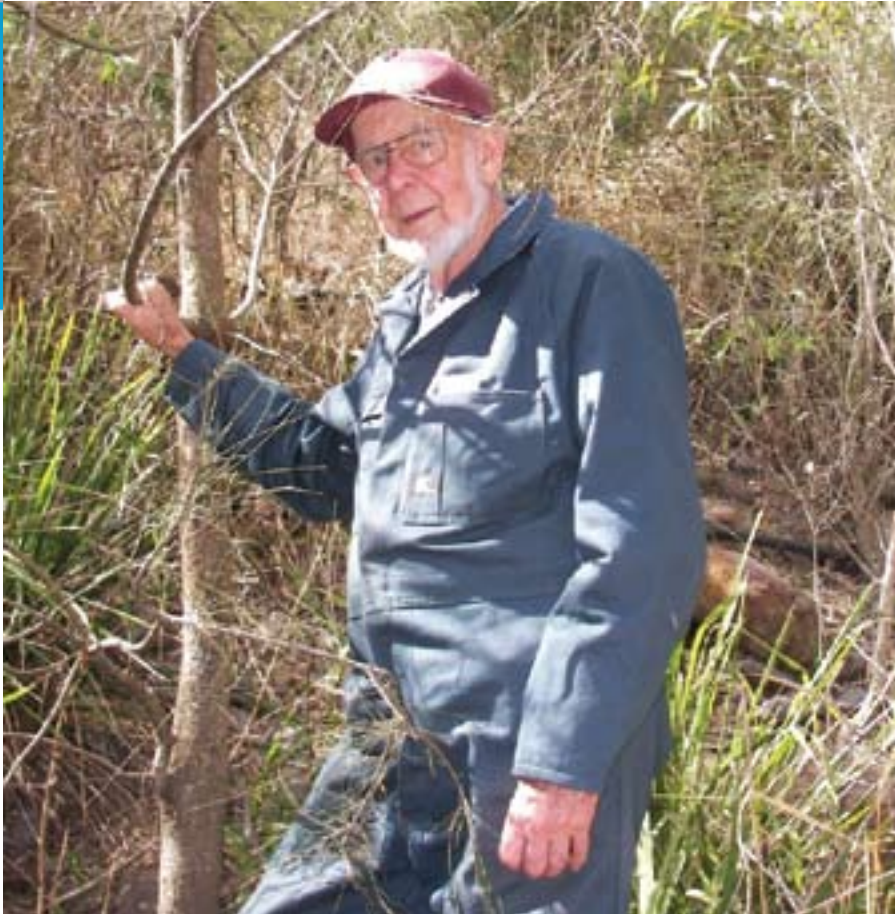
Tenthill resident Jim McDonald with she-oak (*Casuarina cunninghamiana*) and lomandra, two important species for stabilizing creeks.

easier for plantings at the top of the bank, with problems increasing as plantings are undertaken closer to the streambed.
