# Natural Regeneration

Potential for landscape change

## Natural Regeneration: a low cost option

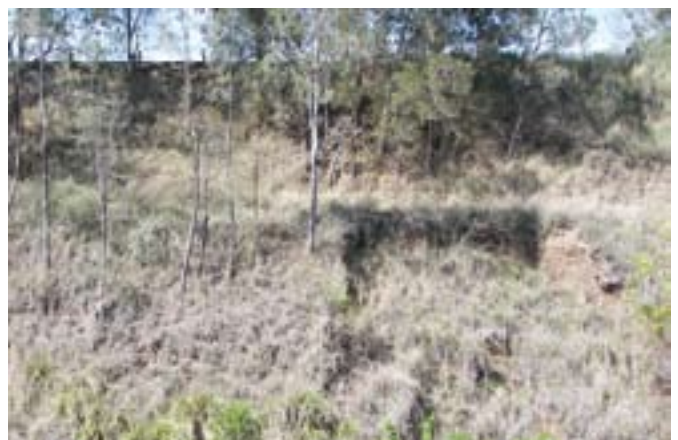
On Laidley Creek young natural regeneration has been important for preventing slumping.

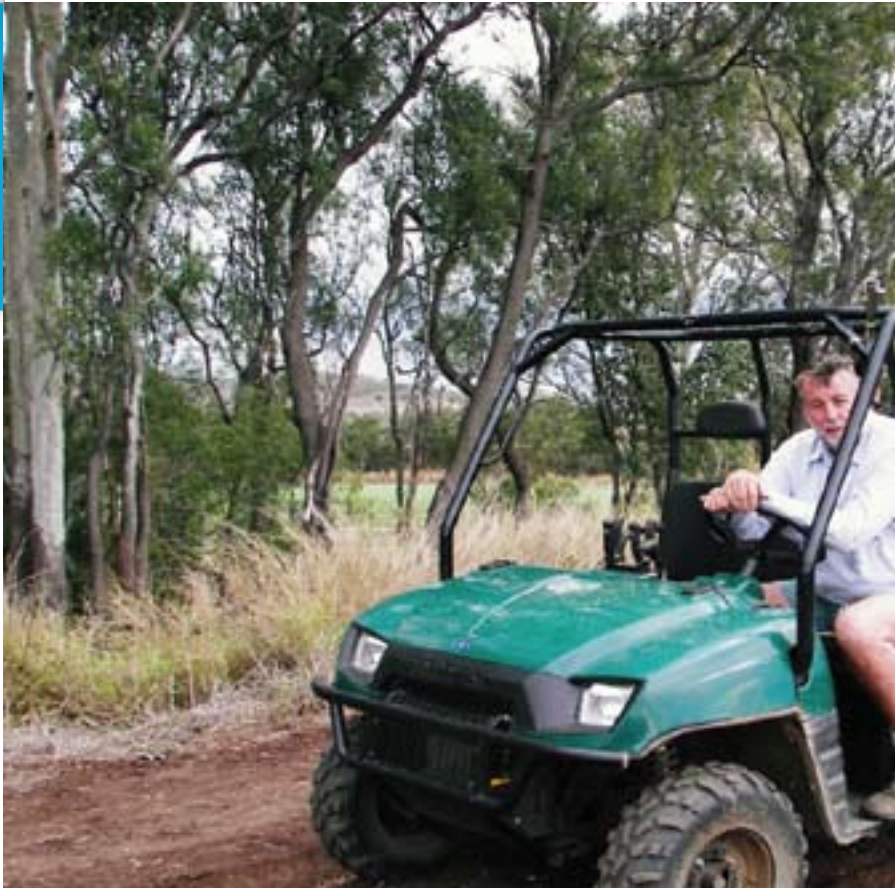
Free trees: By keeping stock and fire out of the creek line, Tenthill farmer John Bishop has encouraged considerable natural regeneration of trees.

According to Tenthill Creek fig producer and former vegetable farmer, John Bishop, creeks can be revegetated in many parts of the Lockyer using low cost natural regeneration techniques. John's management strategies can be as basic as keeping the stock and fire out of the creek lines.

Now twenty years later, the Bishop's section of Tenthill Creek has many more mature trees. Common species present are Moreton Bay ash (*Corymbia tessellaris*), forest red gum (*Eucalyptus tereticornis*), weeping bottlebrush (*Callistemon viminalis*) and sally wattle (*Acacia salicina*).

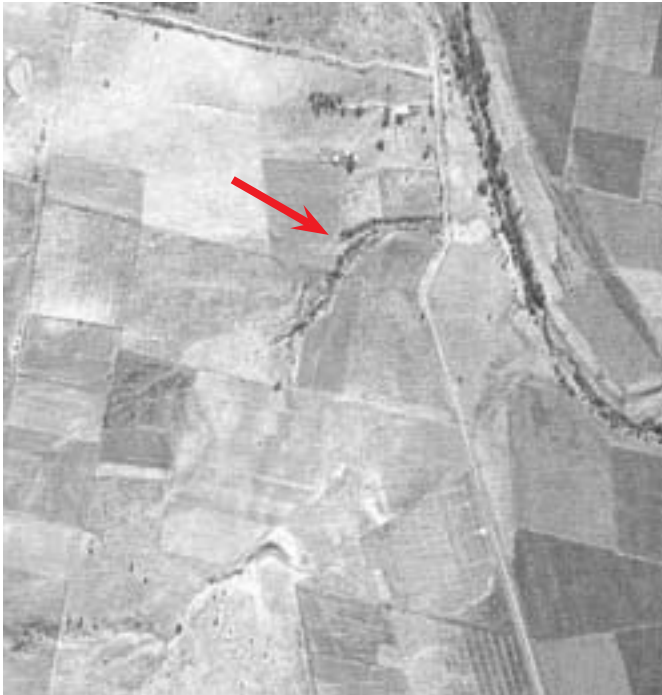
1933 RAAF air photograph showing a bare gully indicated by the red arrow.

A comparison of air photographs taken of Tenthill Creek between 1933 and 2007 shows a waxing and waning of vegetation cover that can largely be explained by changing farm practices. Most interesting is the natural regeneration that has occurred in some areas.

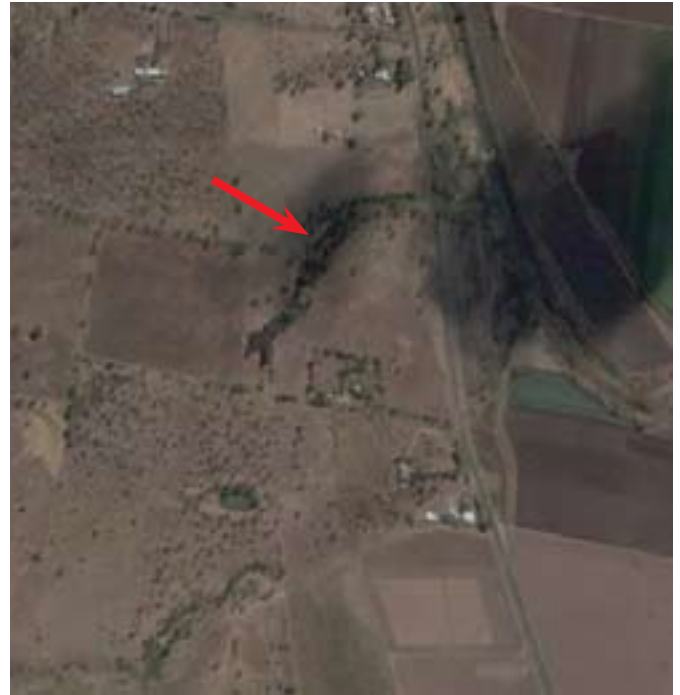
A photograph taken in 2007 of the same gully, which is now revegetated by means of natural regeneration.

Each individual block in the Tenthill Creek catchment has its own history but, generally in the lower reaches of the creek, less grazing occurs now than in the past, and over that time an increase in cover by natural regeneration has occurred.

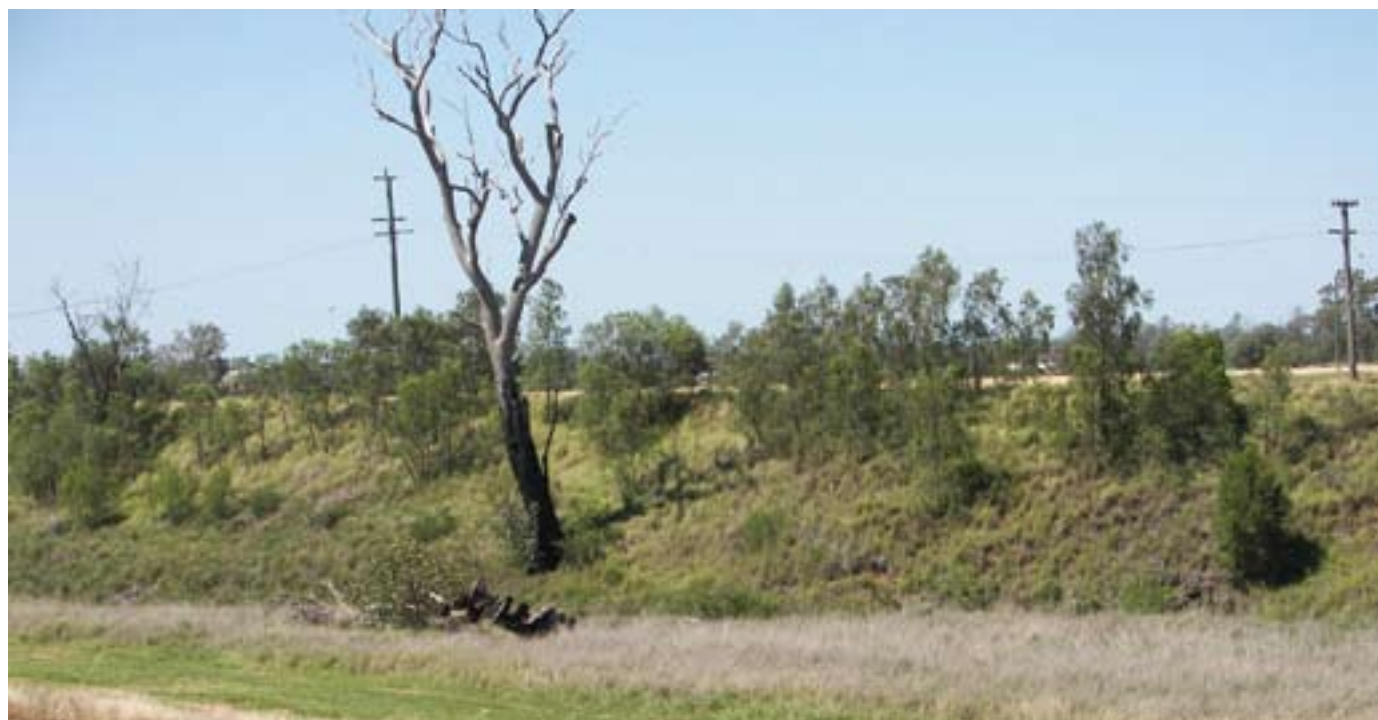
Young acacia regeneration is the first species to appear along Tenthill Creek providing bank stability. Eucalypts and black tea tree (*Melaleuca bracteata*) are also beginning to appear.
